# Manhole Inspection Summary

Manhole # S25I\_\_051MH

Insp Date: **3/13/08 2:39 PM**

**Location** Address: **Lemmon St**

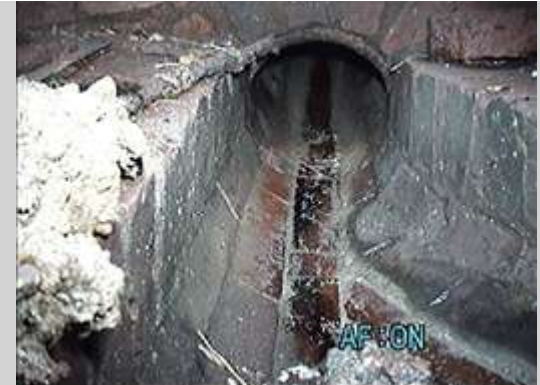
12 O'Clock Outflow

Pipe Height: **8.4** (in.) Rod and Bar (Angled)  
Pipe Material: **Clay** ☐ Pipe Lined  
Invert Depth: **8.52** (ft.) Flow Characteristics: **None**  
Deposits: ☒ None ☐ Mud ☐ Sludge ☐ **Debris** ☐ Grease  
Silt Depth: **2** (in.) Deposits Extent:  
Infiltration: **None** Pipe Seal Cond: **Sound**

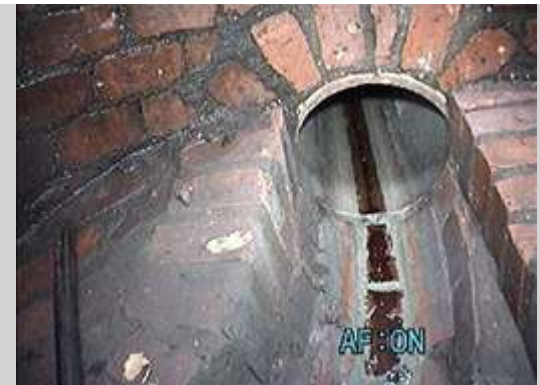
3 O'Clock Inflow

Pipe Height: **8.4** (in.) Rod and Bar (Angled)  
Pipe Material: **Clay** ☐ Pipe Lined  
Invert Depth: **7.92** (ft.) Flow Characteristics: **Slow**  
Deposits: ☒ None ☐ Mud ☐ Sludge ☐ **Debris** ☐ Grease  
Silt Depth: **0** (in.) Deposits Extent:  
Infiltration: **None** Pipe Seal Cond: **Sound**
